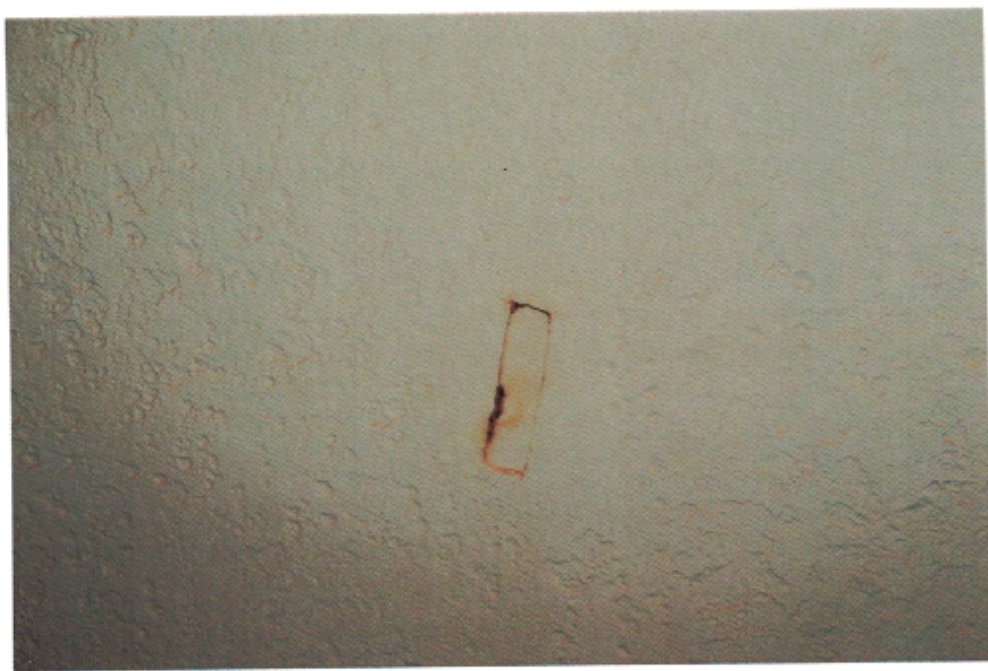
- I-14 View of the shell, illustrating a cut-out that appears to have been patched from the exterior of the reservoir.

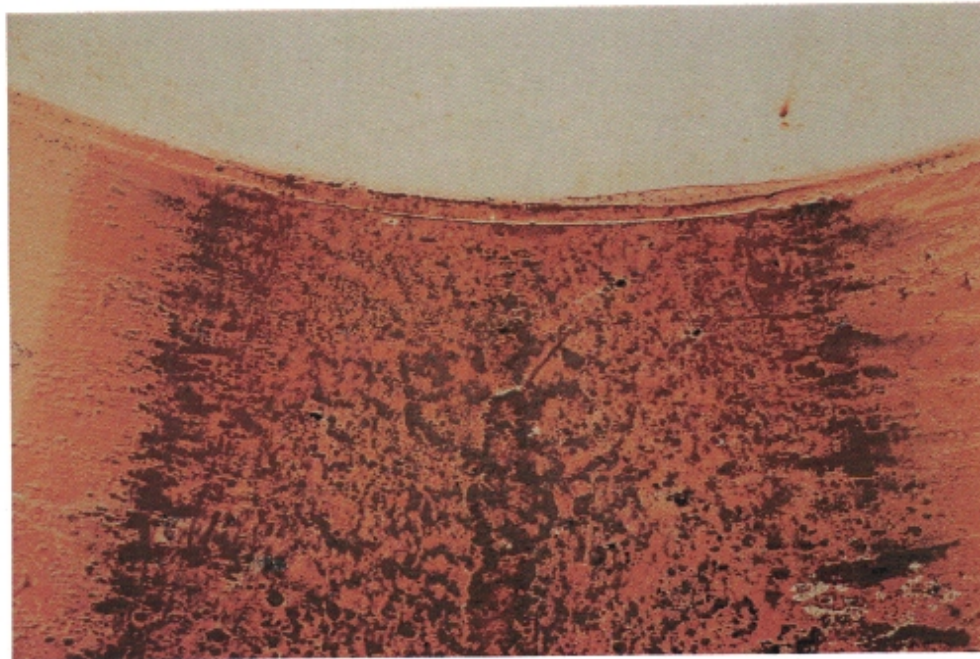
- I-15 View of the lower portion of the reservoir, illustrating dark sediment on the bottom surfaces and minor spot corrosion on the dished head.

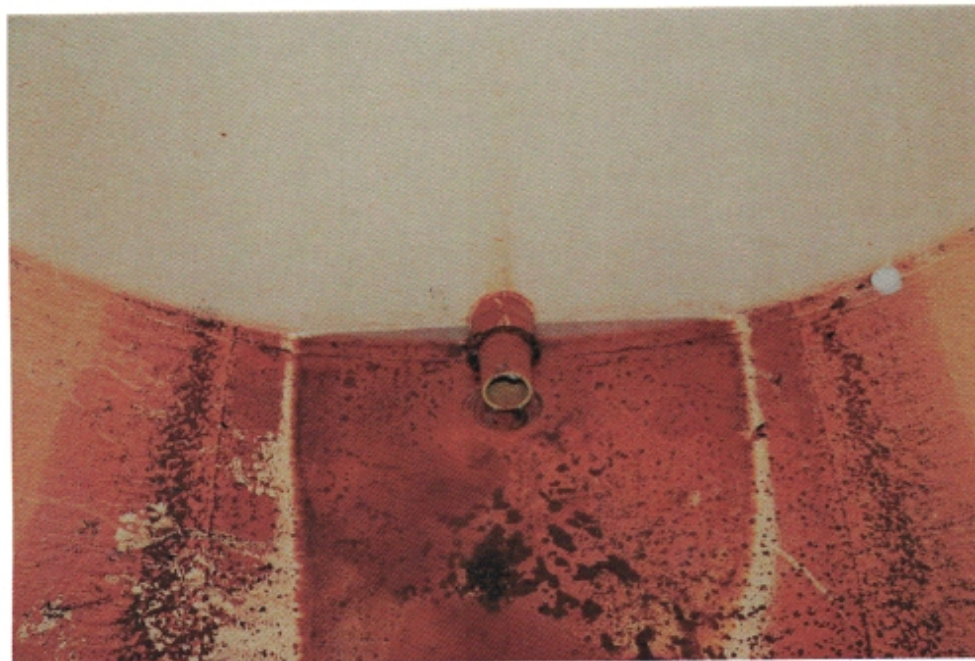
- I-16 Same as Photo I-15, except at the opposite end of the reservoir.

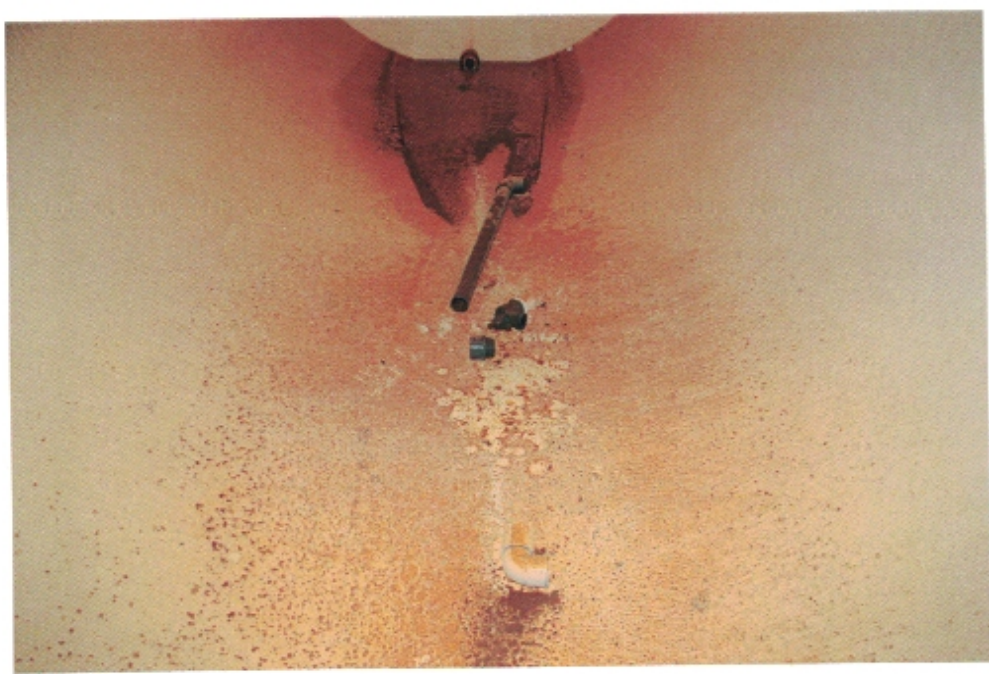
- I-17 General view of the bottom of the reservoir, illustrating random debris present.

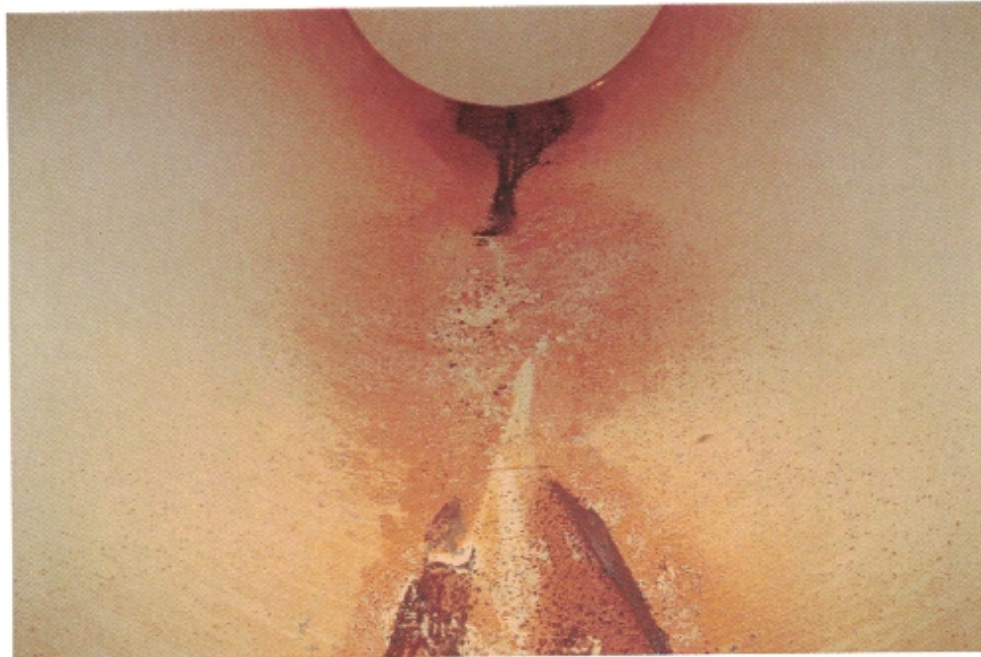
- I-18 Same as Photo I-17, except from the opposite end of the reservoir. Note the debris has been removed.

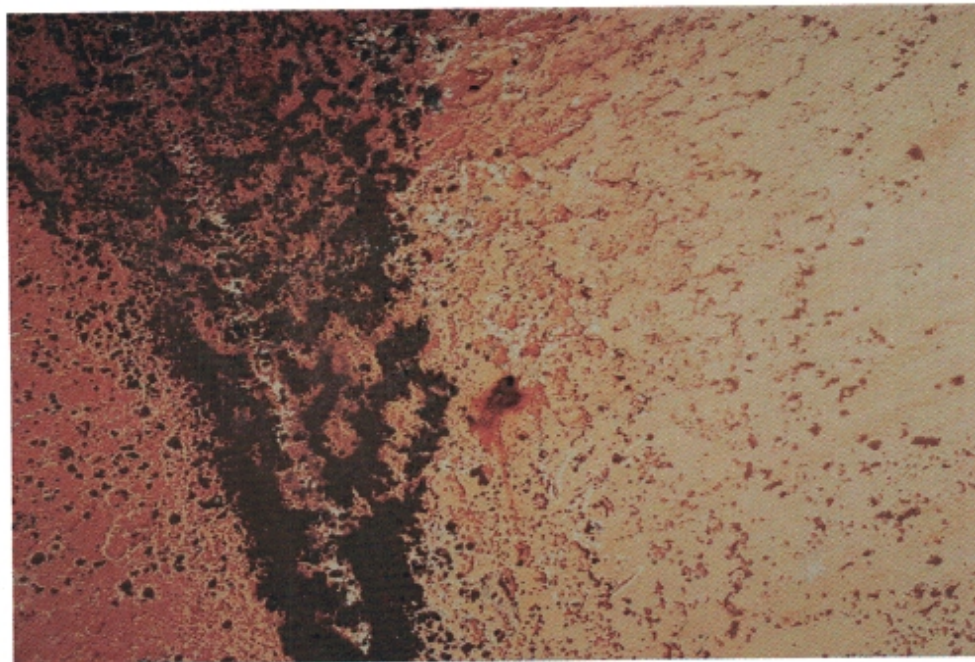
- I-19 Close-up view of the bottom, illustrating a rust tubercle present.

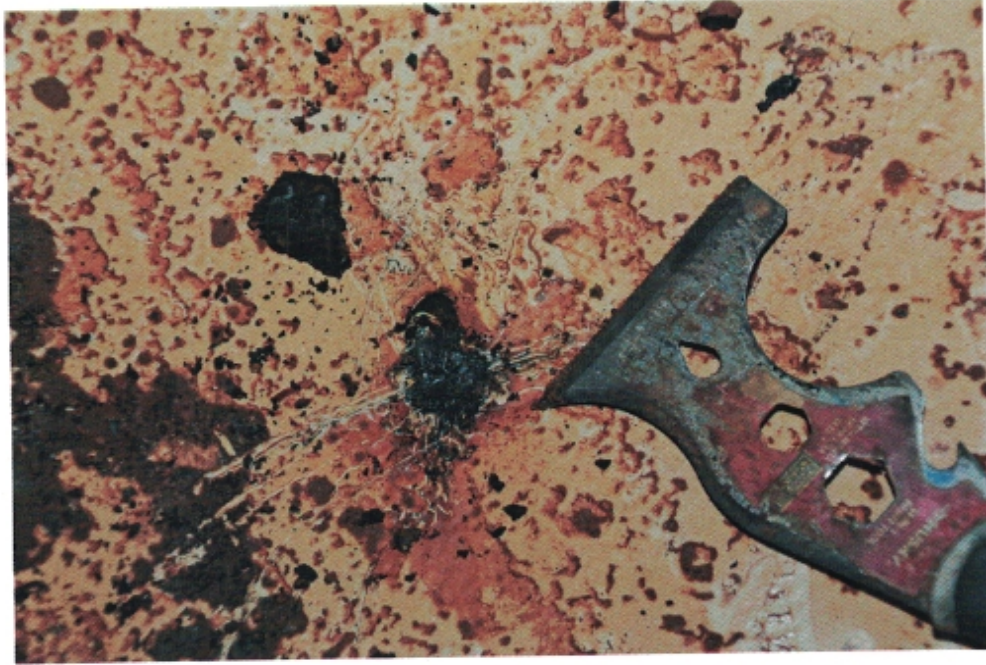
I-20

Same as Photo I-19, except the rust tubercle has been removed to examine the substrate. Note moderate to severe pitting present.

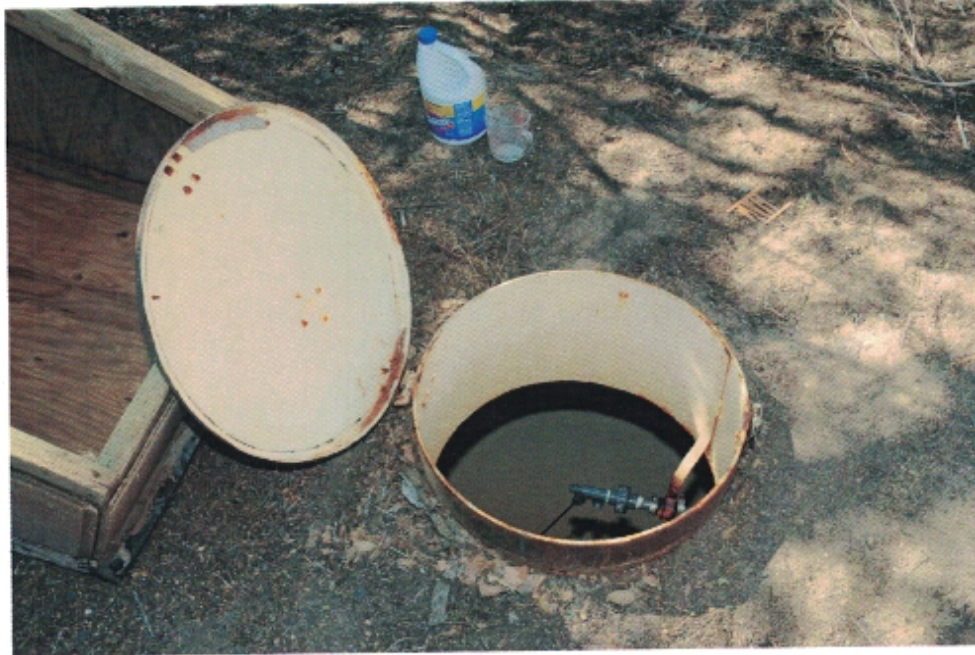
I-21

View of the manway from above, illustrating delamination on the underside of the cover and minor corrosion along the top edge of the hatch curb.

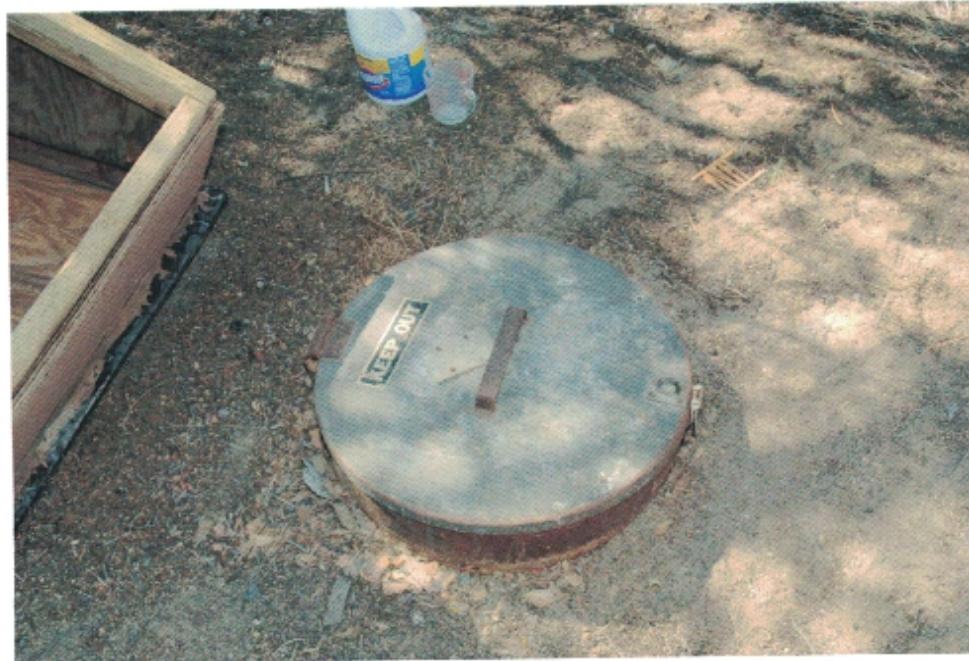
I-22

Same as Photo I-21, except the hatch is closed. Note moderate general corrosion on the handle, hinge, and exterior of the hatch curb.

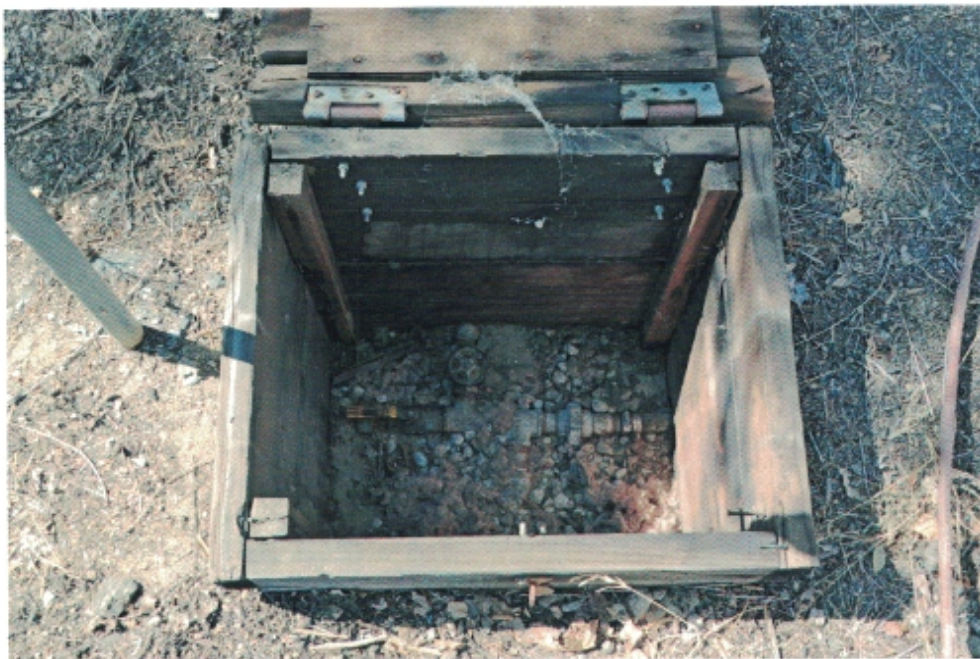
- I-23 View of the inlet vault, illustrating minor mechanical damage and corrosion on the piping and valve.

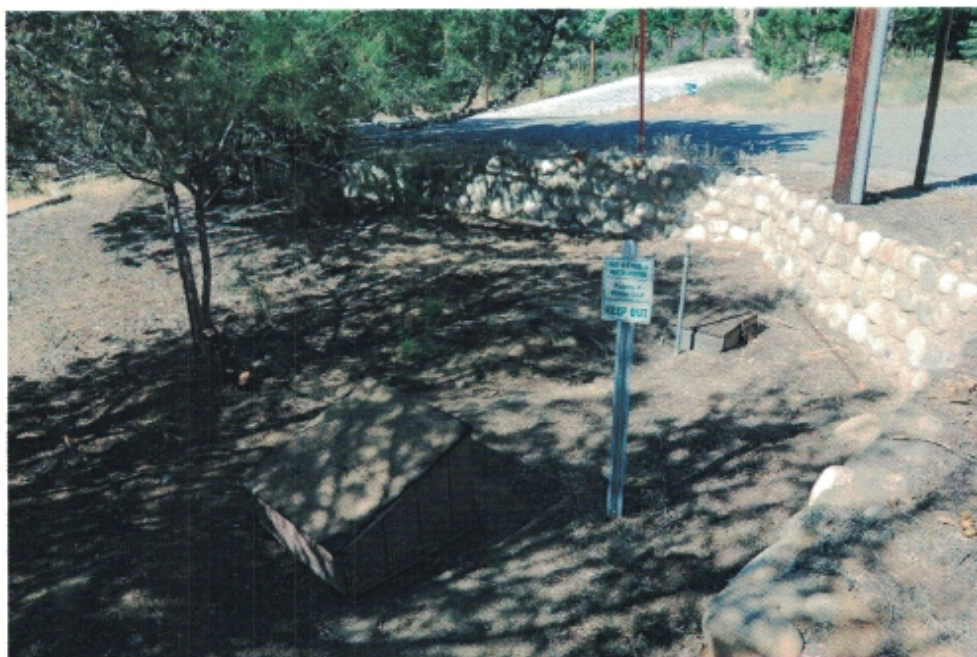
- I-24 General view of the site above the reservoir, illustrating the hatch cover and inlet vault.
